The Slope Instability Along Transport Arteries – A Major Environmental Hazard, Case Study: Road Running from Labha to Paparkheti, District: Darjeeling,West Bengal

Dr. Soma Bhattacharya, Principal, Department of Geography Vivekananda College for Women, Kolkata, West Bengal, India

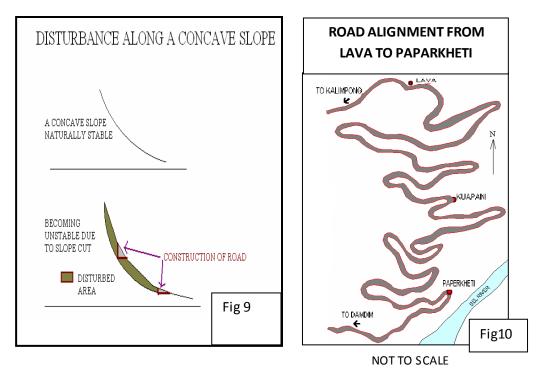
5) <u>Man-made constructions</u>:- Construction, that deteriorate slope stability are of many types like the bridges, barrages, dams, brick houses with two to three storied floor all disturb slope and put pressure on it but construction of road (which is otherwise important for communication and development of hill area) disturbs slope maximum particularly when the slope is itself vulnerable due to the factors mentioned above. Normally we know convex slope is unstable due to its own form. So leaving the question of convex slope we can see how construction of roads at different levels makes slope unstable, as the upper part of the slope above the road remains hanging without any balance (Fig 9). There are thirteen road benches existing (Fig 10) on one slope along the Paparkheti – Lava road. This means the normal slope angle is disturbed at thirteen levels by the road, as a result of which almost every upper level suffers subsidence and slides due to under-cut by the construction of the lower level. Such subsidence and slides are common even in the areas with guard wall.

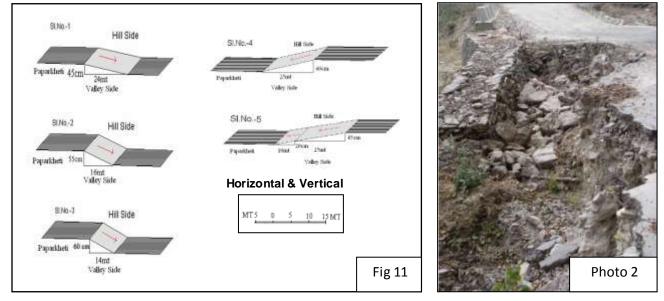
Major Subsidence

Subsidence in an area with guard wall

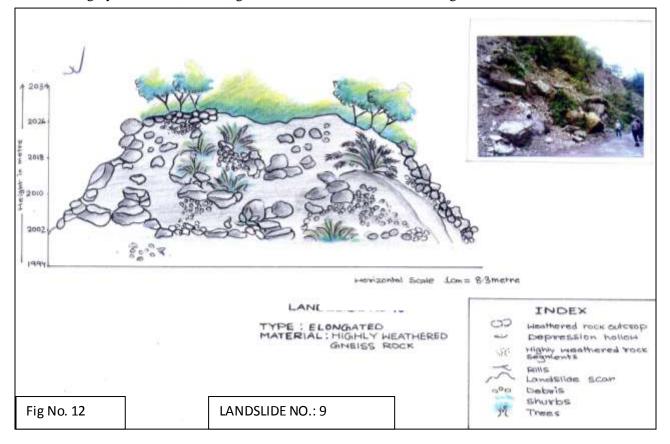
Description of landslide no. 9:- This landslide is an example of elongated slide. This is located at 6.3 km from Lava. Total length of the landslide is 95.5 m. and the highest height of the landslide is 35 m. The landslide material is highly weathered, foliated, gneissic rocks and mica-schist. In high rainfall areas

gneissic rocks are deeply weathered and susceptible to slope failure. Slope angle of the landslide is 45°. The blocks of rocks in the slide are separated and fall along bedding plane. However the growth of bushes indicates that the slides is not active at present but the sparseness of vegetation indicates a scar of recent past and may become active at any time if any of the immediate reasons like high rainfall, tectonic jerks, increase in pore water pressure etc. occurs.

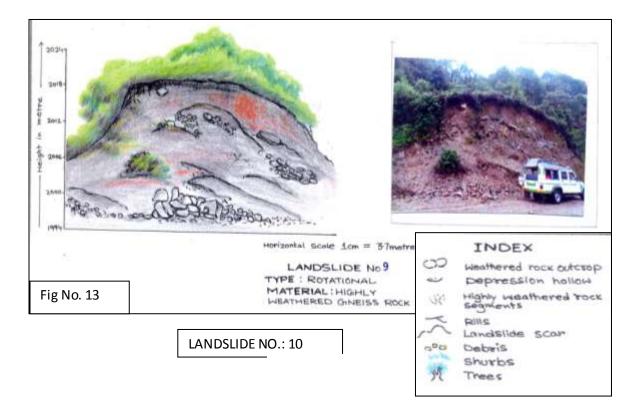
Description of landslide no. 10: This landslide is an example of rotational slide (Fig 13). This is located near 4 km from Lava. Total length of the landslide is 29.6 m. and the highest height of the landslide is 30 m. The landslide material is highly weathered gneissic rock. In high rainfall areas gneissic rocks are deeply weathered and susceptible to slope failure. Slope angle of the landslide is 29°. The slope form of the slide is concave. It means that the sliding actively has stopped. The growth of vegetation though sparse indicates that the stability of slope.

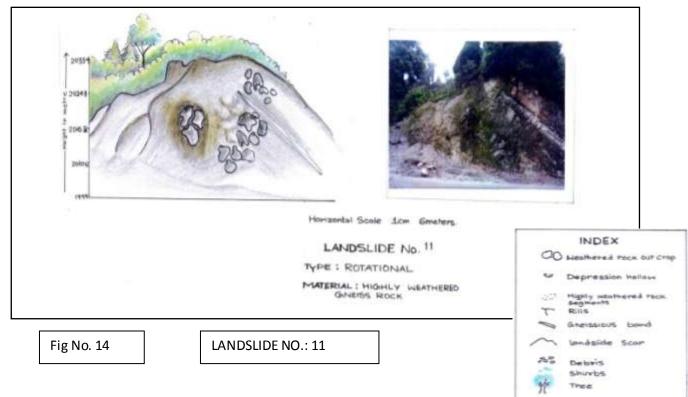
Description of landslide no. 11:- This landslide is rotational and located at 2.5 km from Lava. Total length of the landslide is 50.4 m. and the maximum height of the landslide is 35 m. The landslide material is highly

weathered gneissic rock. In high rainfall areas gneissic rocks are deeply weathered and susceptible to slope failure. Slope angle of the landslide is 28°. The slope form of the landslide is convex it means that the slope of the landslide is unstable and it is easily susceptible to another failure. In lower part of the landslide many small rills are formed due to water action. Some boulders and debris are found in the bottom of the slide.

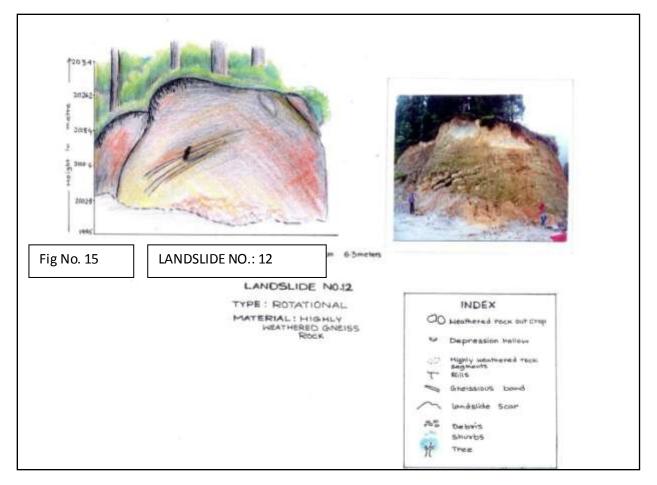
Description of landslide no. 12:- This landslide is an example of rotational slide. This is located at 2 km from Lava. Total length of the landslide is 47.3 m. and the maximum height of the landslide is 34.4 m. The landslide material is highly weathered gneissic rock. In high rainfall areas gneissic rocks are deeply weathered and susceptible to slope failure. Slope angle of the landslide is 36°. The slope form of the landslide is rectilinear, it means that the slope of the landslide is not stable and the chance of further failure is fifty fifty. The lower part of the landslide is active and this part is also a bit convex. Many small rills are formed due to water action. Some gneissic boulders are found on the slope and weathered rocks of different size are present in the bottom of the slide.
