The Slope Instability Along Transport Arteries – A Major Environmental Hazard, Case Study: Road Running from Labha to Paparkheti, District: Darjeeling,West Bengal

Dr. Soma Bhattacharya, Principal, Department of Geography Vivekananda College for Women, Kolkata, West Bengal, India

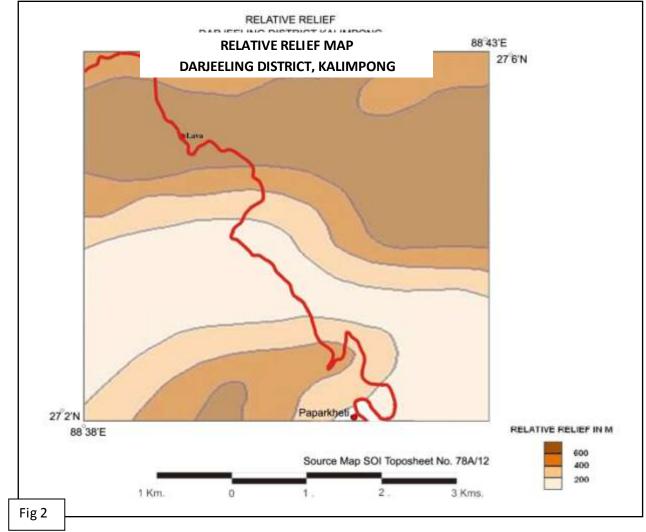
the topmost part of a valley side slope and the lowest depth of the valley. The steepness of the relief of the area has been assessed by Relative Relief Analysis (Highest elevation in a grid – lowest elevation of that grid) with the help of topographical map. Though such assessment gives a very generalized view, even then the relative relief indicates the steepness of the area with more than 80% of the area showing relative relief above 400 meter and more than 40% of that showing a relative relief of more than 600 meter. High relative relief undoubtedly indicates a high steepness and a huge fall from the hill top to the adjacent valley floor, a factor responsible for slope instability. (Fig 2)

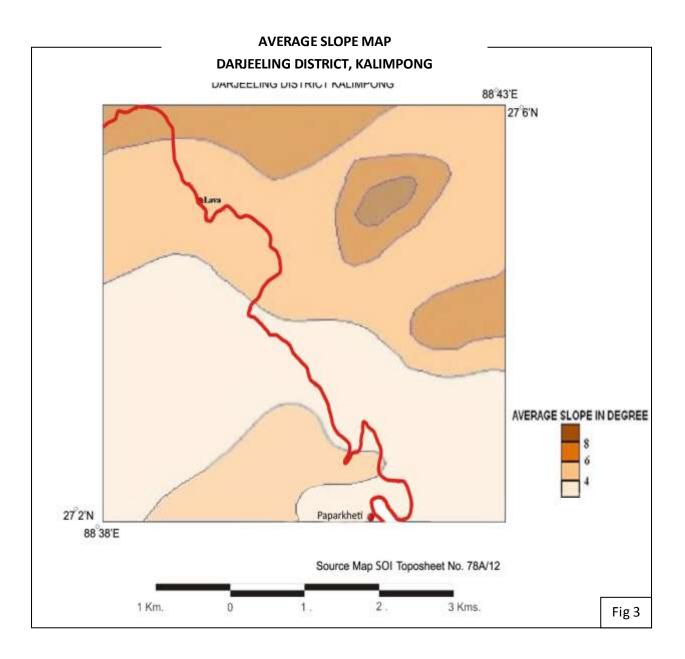
Degree of slope and form: - After relative relief the second relief factor which is most important for slope instability is the slope amount and form. Slope amount has been determined by Wentworth's method. Again more than 80% of the area shows more than 4^o slope angle and about 40% shows more than 6° slope angle. Obviously the area which shows high relative relief shows high slope angle. (Fig 3) Slope form is also another important factor for slope instability, as we know the convex slope is one of unstable kind, while rectilinear slope is relatively stable. Due to river under-cut convex slope is very common in the area causing instability. Construction of roads is another important cause for deliberate change in slope form and thus resulting instability which will be discussed later.

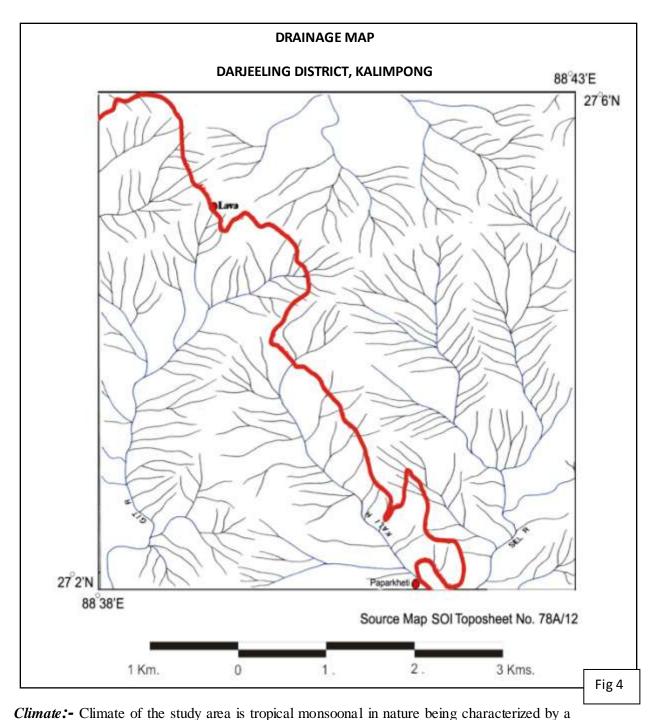
drainage, which undoubtedly increases the probability of slope instability. Moreover high rainfall allows seepage of fine clay and silt by a drag effect due to seepage pressure of water thus loosening the entire slope material. (Fig 4)

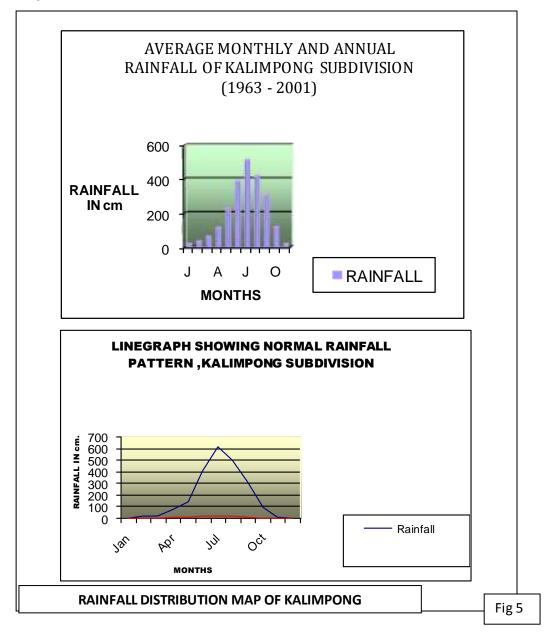
very high temperature ranging from 7° C - 10° C winter temperature to 17° C - 22° C summer temperature. The second important characteristic of climate is huge rainfall and its intensity and seasonal distribution. The mountain front is subjected to huge precipitation. The Kalimpong hills receive annual rainfall ranging from 200 cm. to above 600 cm. The seasonal distribution of precipitation (Fig 5) and its concentration

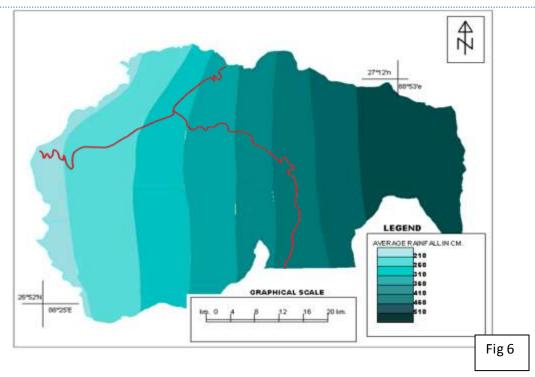
during one half of the year creates immense problems leaving practically no slope stable due to deep weathering and huge pore water pressure. The maximum concentration of landslide incidences occurs between 2100mm to 4100mm isohyets. The road sector running between Lava and Paparkheti falls into the zone receiving quite high rainfall (410 cm. - 460 cm.) (Fig 6) Naturally the region is highly susceptible to deep weathering and landslides.

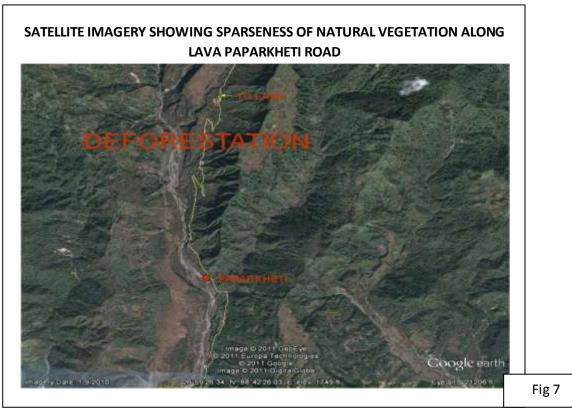
from the top of the hills to the very bottom of the valleys with a dense forest.' Now forests stand below 1000metre and above 2000 meter (Fig 7).

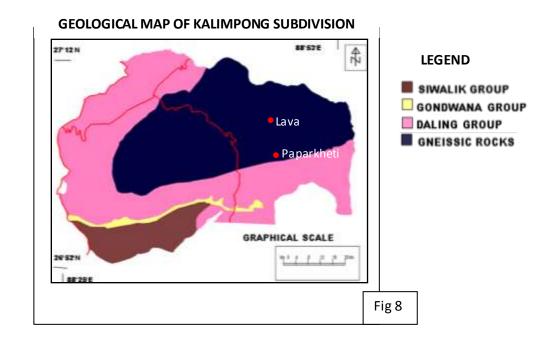
The rock foliation strike is N 25° W-S 25° E and dip at 45° towards N 65° E. The dip and strike of rock foliation are indicative to slope failures and it is strikingly observable that almost all the subsidence and slides are confined to the east dipping rock, that is, the dip slope of the Paparkheti – Kuapani ridge. Slope failures are rare or almost absent on west and south facing slopes. Thus the road sectors which are along anti dip slopes are almost free from slope failures.
